Manhole Inspection Summary

Manhole # S270__001MH

Location Address: **1187 W Ostend St**

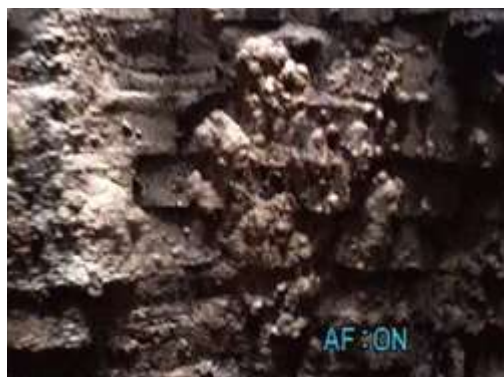
Defect 5

Infiltration: ☐ None ☐ Joint ☐ Cracks ☐ Mortar ☐ Roots ☒ **Wall**

signs of infiltration in barrel wall

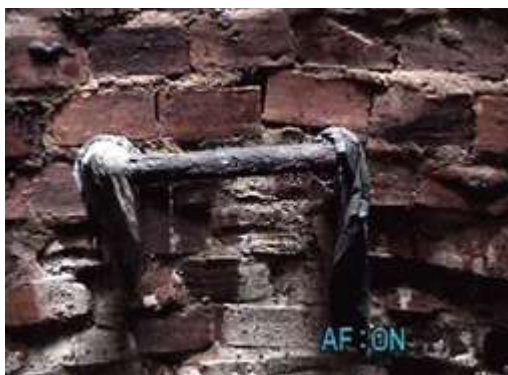
Defect 4

☒ **Evidence Of Surcharge**

signs of surcharge

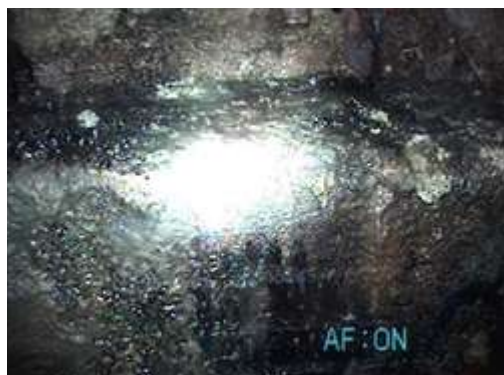
Defect 3

Condition: ☐ Sound ☐ Cracked ☐ Root Intrusion ☐ Deteriorated ☐ Leaks ☒ **Debris**

debris on bench

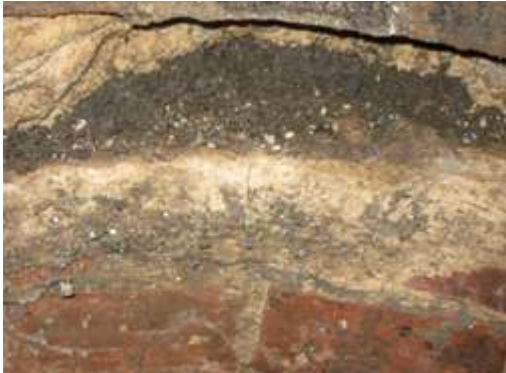
Defect 2

Infiltration: ☐ None ☒ **Joint** ☐ Cracks ☐ Mortar ☐ Roots ☐ Wall

signs of infiltration at chimney joint

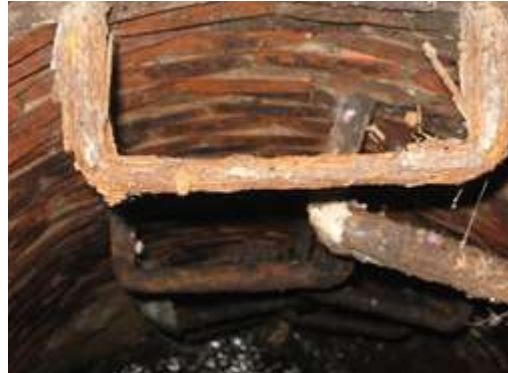
Defect 1

Count: **10** Missing: **1** ☒ **Corroded**

rusting rungs

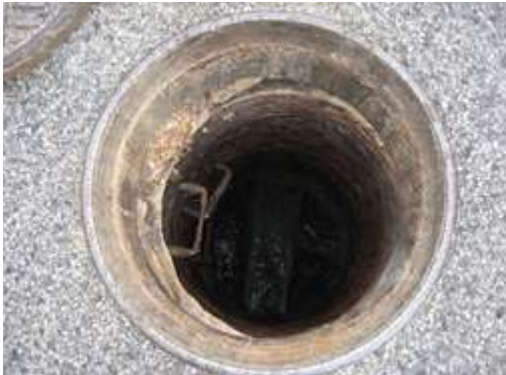
Defect 6

Offset: **2.** (in.)
25

frame offset

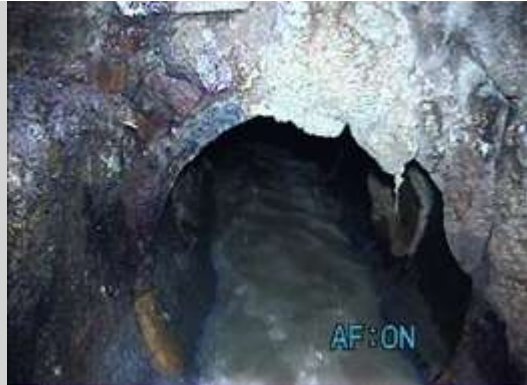
12 O'Clock Outflow

Pipe Height: **24** (in.) Rod and Bar (Angled)
Pipe Material: **Clay** ☐ Pipe Lined
Invert Depth: **16.96** (ft.) Flow Characteristics: **Turbulent**
Deposits: ☒ None ☐ Mud ☐ Sludge ☐ Debris ☐ Grease
Silt Depth: **0** (in.) Deposits Extent:
Infiltration: **Evidence** Pipe Seal Cond: **Unknown**

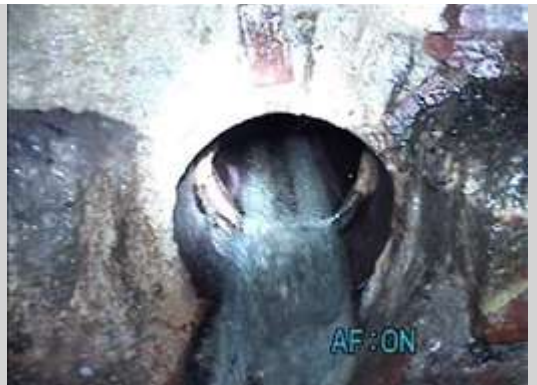
3 O'Clock Inflow

Pipe Height: **12** (in.) Rod and Bar (Angled)
Pipe Material: **Clay** ☐ Pipe Lined
Invert Depth: **15.90** (ft.) Flow Characteristics: **Fast**
Deposits: ☒ None ☐ Mud ☐ Sludge ☐ Debris ☐ Grease
Silt Depth: **0** (in.) Deposits Extent:
Infiltration: **Evidence** Pipe Seal Cond: **Unknown**

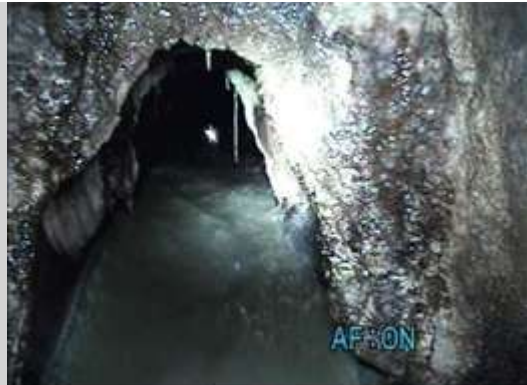
6 O'Clock Inflow

Infiltration: **Evidence** Pipe Seal Cond: **Unknown**
